Low-Cost Shore Protection

Final Report on the Shoreline Erosion Control
Demonstration Program (Section 54)
1981

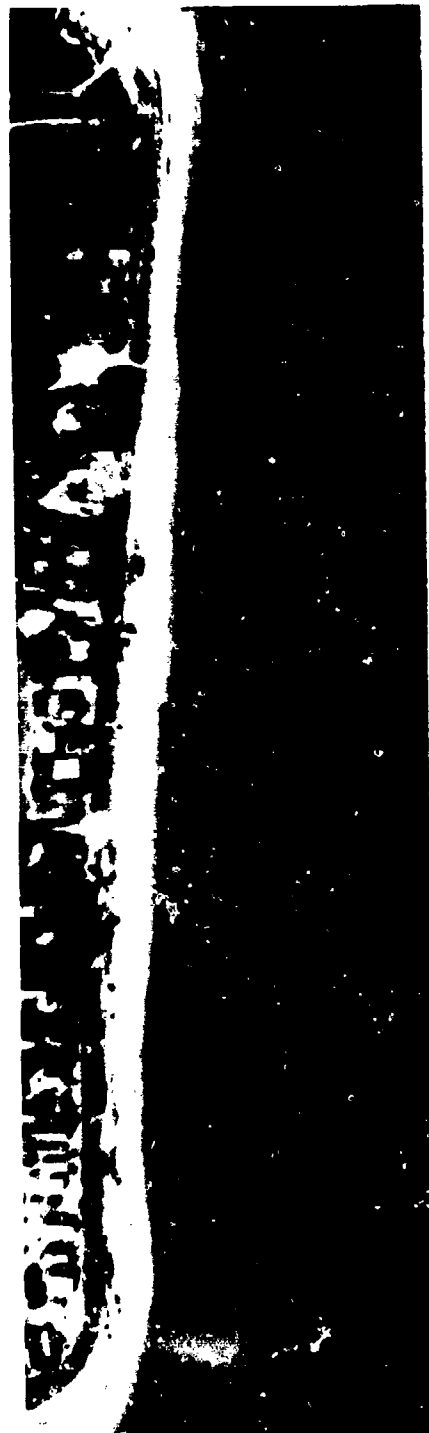
(3) Performance. No additional beach nourishment projects have been required at Bowers since the summer of 1974. The groins have been somewhat effective in retaining the beach fill, although considerable erosion has occurred. Figure 2-26 illustrates the performance of the beach fill and groins. Material has accreted on the north side of the south groin, which suggests a dominant northwest to southeast littoral transport. Also, a smaller amount of accretion has occurred just south of the north groin, indicating an occasional change in direction of the littoral transport, i.e., a southeast to northwest transport. The profiles in Figure 2-27 show that about 20 feet of beach fill eroded between April 1979 and March 1980.

Figure 2-26. Groin-retained beach fill at Bowers, Delaware (top photo, 9 March 1979; bottom photo, 18 October 1979).

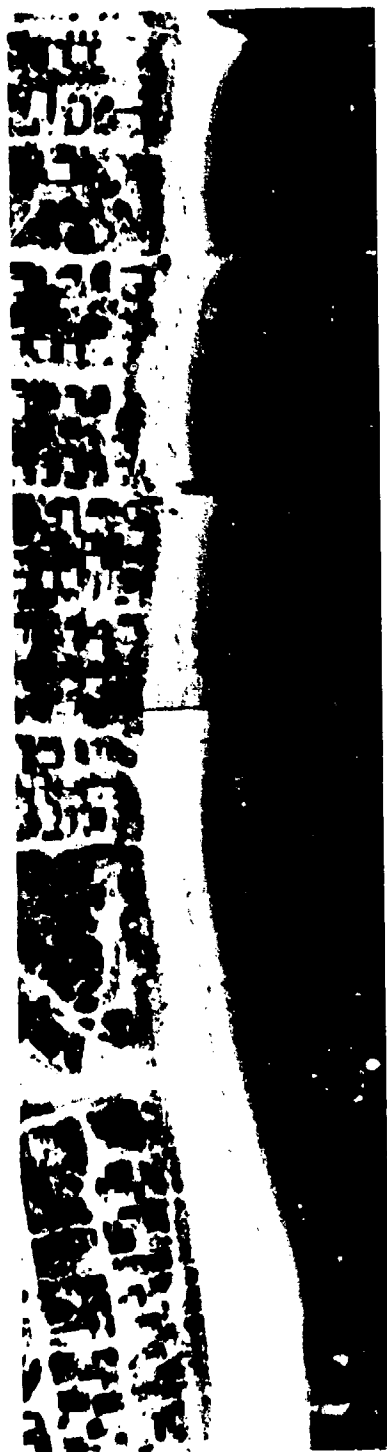
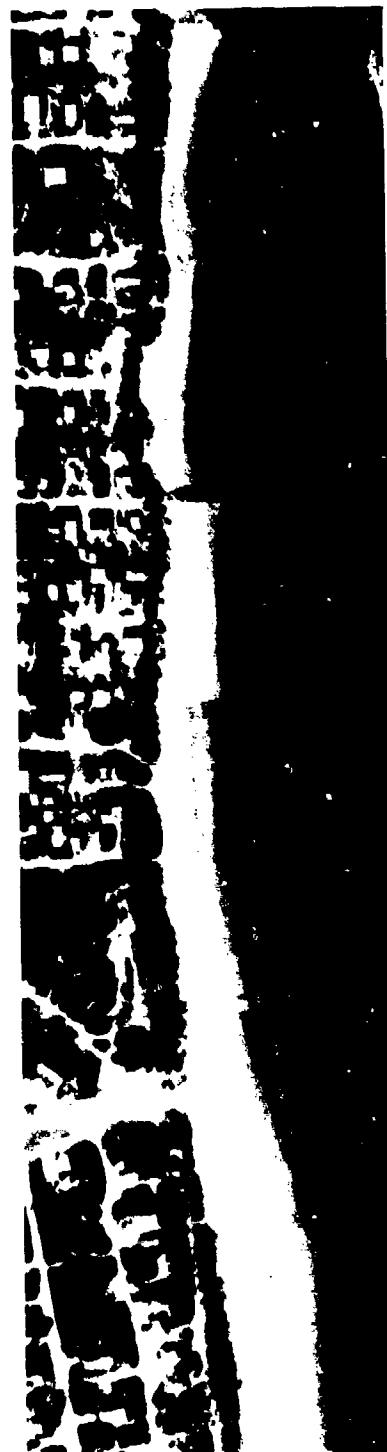
(3) Performance. The groin field has retained the beach fill placed in 1976 and no renourishment projects have since been required. The contour changes were too small to show on the General Plan, but Figure 2-41 illustrates the functional performance of the groin-retained beach fill.

Figure 2-41. Groin-retained beach fill at Broadkill Beach, Delaware (top photo, 9 March 1979; bottom photo, 18 October 1979).

Beach fill has accreted on the south side of each groin demonstrating the dominant southeast to northwest littoral transport. The aerial photo also reveals an important difference between the performances of timber groins and concrete rubble groins. The concrete rubble groin allows sand to pass through it and thereby nourish the downdrift beach; however, sand must pass around the timber groin before moving on to the downdrift beach. The beach alignment next to the timber and rubble groins at stations 16+40 N and 11+70 N, respectively, demonstrates this difference. The profile at station 23+00 N, just north of the groin field (Fig. 2-42), shows about 20 feet of erosion between April 1979 and March 1980. This further demonstrates the southeast to northwest littoral transport and that the groin field is effectively trapping littoral drift.

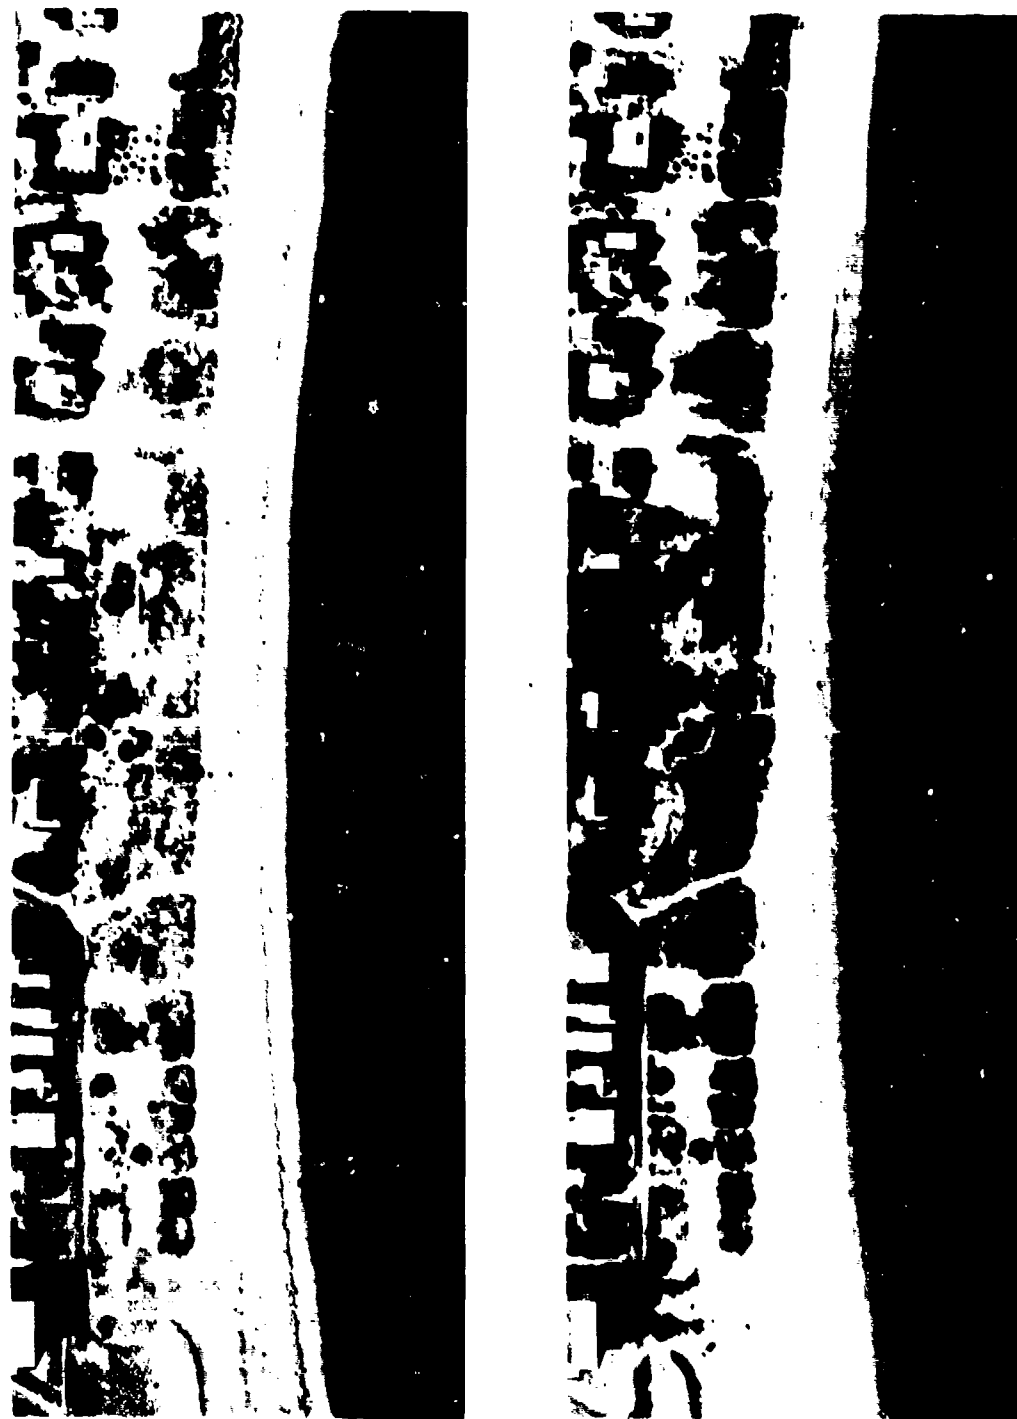
(3) Performance. Shoreline erosion along the beach at Lewes has been controlled only by the placement of a protective beach fill. Aerial photos reveal no dramatic changes during the relatively short timespan from March to October 1979 (Fig. 2-44), and the scale of the General Plan is too small to plot contour changes. However, profiles taken from surveys made between April 1979 and April 1980 (Fig. 2-45) show a retreat of the beach berm of about 50 feet near the west and tapering to only a few feet near the east end of Lewes beach. This is indicative of a strong eastward transport of littoral drift along this reach.

Figure 2-44. Aerial photos of the beach nourishment at Lewes, Delaware (top photo, 9 March 1979; bottom photo, 18 October 1979).

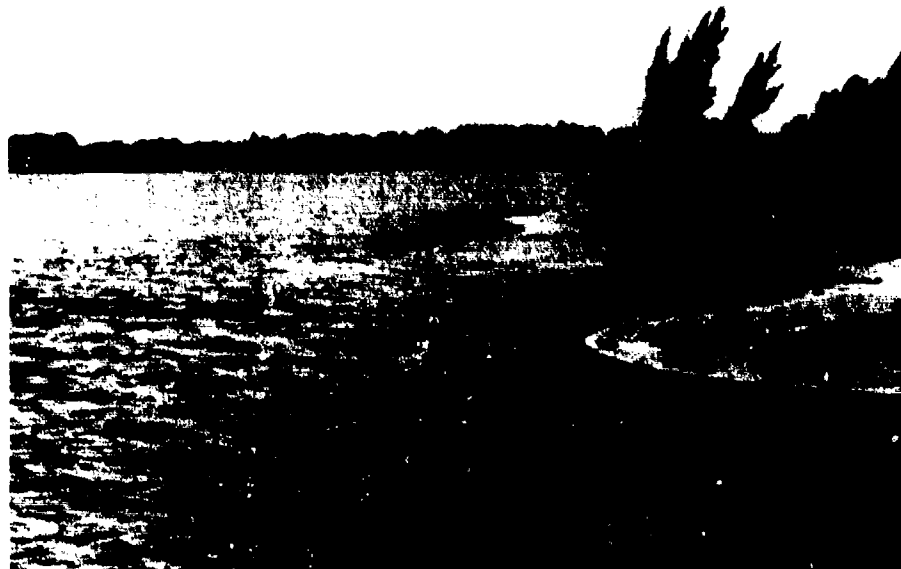
(e) Site 3S (Vegetation and Temporary Tire Breakwater). Assembly of the floating tire breakwater was completed by the Florida Institute of Technology in June 1979. It was assembled in sections onshore, then the sections were combined and anchored 300 feet offshore. The alignment of the structure shifted after being anchored and began orienting itself perpendicular to the approaching wave fronts (Figs. 2-58 and 2-59). Polypropylene rope with a nylon protective cover (0.5 inch) was used to bind the tire clusters together. Once installed, the rope wore through the rubber coating covering the steel band around the inside rim of the tires as a result of wave agitation. The exposed steel band then frayed the rope, eventually causing it to fail. Inspection of the breakwater indicated that a heavy growth of marine organisms (oysters and barnacles), as well as some accumulation of silt, was observed in the submerged parts of the tires. Nevertheless, the structure was effectively attenuating the normal wave activity at the site.

Figure 2-58. Floating tire breakwater at Stuart Causeway,
Florida, 4 May 1979.

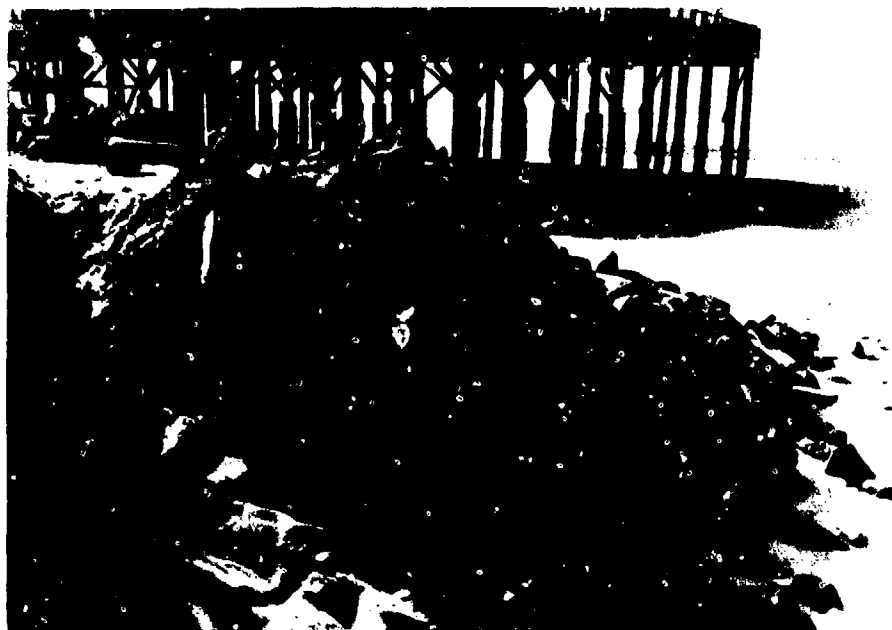
2 Performance. No change in structural alinement or cross section occurred from March to July 1979. In July 1979, wave action during high tide displaced many rocks along the revetment, exposing the filter material (Fig. 2-94) at three locations. This deterioration continued through August, but was not as severe. In early September 1979, Hurricane David destroyed the entire beach at device 2, leveling the revetment and dispersing rocks across Arctic Avenue (Fig. 2-95); the timber groin remained intact.

Figure 2-94. Displaced rock exposing filter material, device 2, Folly Beach, South Carolina, 16 July 1979.

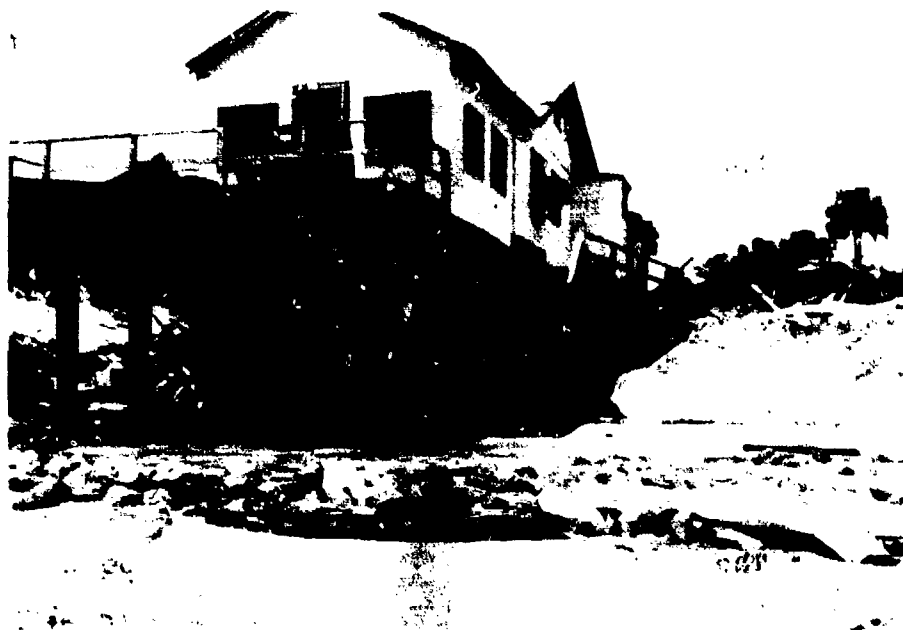
In December 1979 the rock revetments (devices 3 and 5) were rebuilt to higher levels in front of houses 306 and 308. In January 1980 sandfill was added on top of and behind device 3 (Fig. 2-113), and the rocks on device 5 were displaced by waves, exposing the filter cloth (Fig. 2-114). By March 1980 major structural damage had occurred to house 306 behind device 3. It is not known whether wave action damaged the house; however, adjacent houses were not damaged. By May 1980, device 3 was completely destroyed (Fig. 2-115) and more riprap was placed on device 5. As of May 1980

Figure 2-115. Device 3 revetment was completely destroyed, Folly Beach, South Carolina, 29 May 1980.

device 3 had been destroyed, device 4 was still intact, device 5 had been rebuilt, device 6 was still intact, and device 7 had been built up to a higher level. The revetments did not hold up well under normal conditions; the bulkheads were more successful.

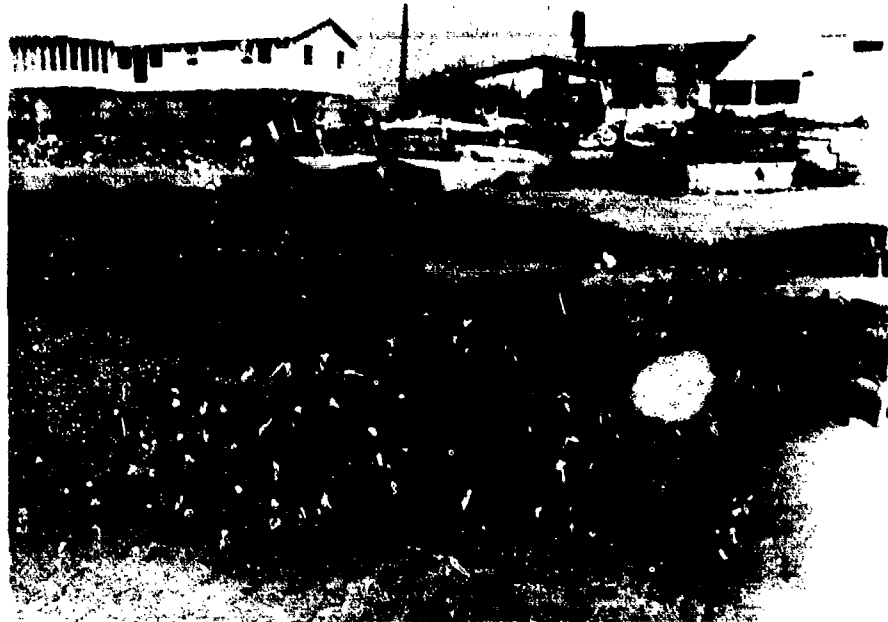
2 Performance. When the monitoring began in February 1979 the devices were in good condition. By July 1979 the Sandgrabbers were deteriorating rapidly. Many of the blocks on the top row of the seaward Sandgrabber were broken. The center of the landward unit was slumping, but few of its blocks were broken (Fig. 2-117). Sections of the concrete-block seawall between the timber piles were leaning in various

Figure 2-117. Broken blocks and settlement of Sandgrabbers, Folly Beach, South Carolina, 27 June 1979.

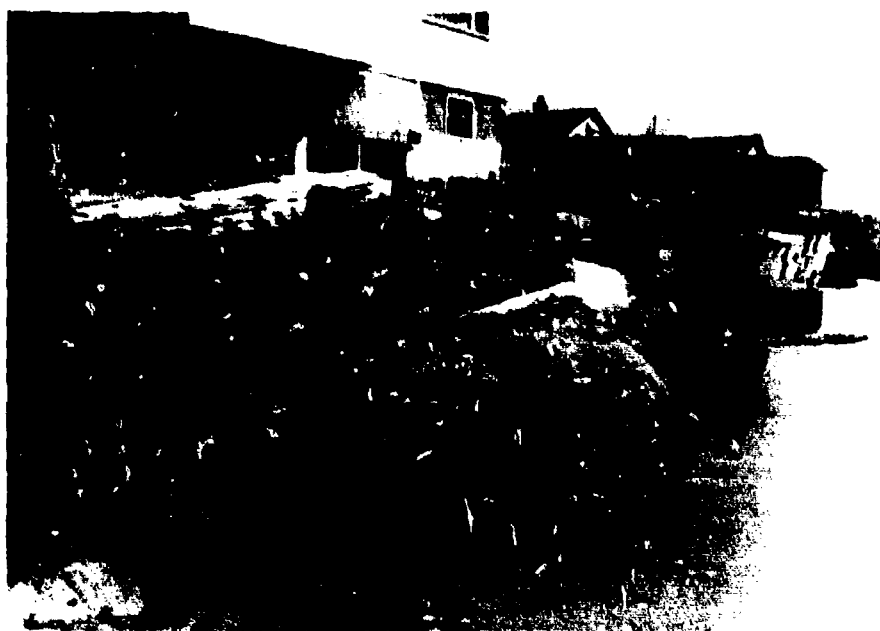
configurations, but the wall remained intact (Fig. 2-118). The condition of the structure did not change much over the next 2 months. The Sandgrabbers continued to deteriorate, and some spalling occurred at the north end of the concrete bulkhead (device 9). The last 60 feet of the bulkhead was destroyed during Hurricane David (Fig. 2-119). The riprap revetment was knocked down but the rocks were not displaced far from the structure (Fig. 2-120). Three sections of the concrete-block bulkhead also fell during the storm (Fig. 2-121). The Sandgrabbers were damaged but held together. The seaward unit was buried up to the top row of blocks. Half of the top row of blocks were missing and many of the blocks that remained were broken. The other Sandgrabber continued to settle and slump, yet only a few of its blocks were missing or broken (Fig. 2-122).

Figure 2-118. Timber and concrete-block seawall, device 10, Folly Beach, South Carolina, 27 June 1979.

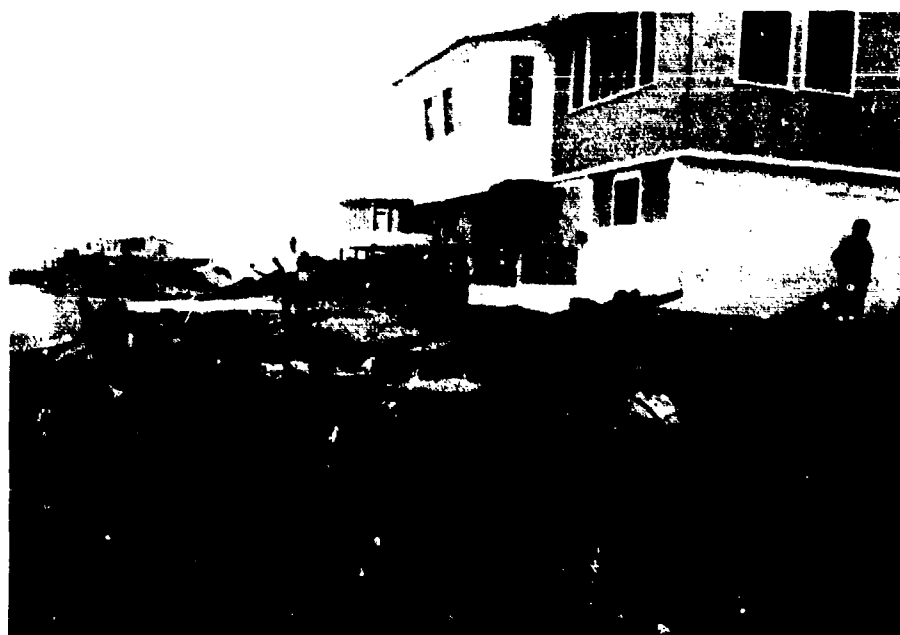
Figure 2-121. Fallen concrete-block bulkhead sections, Folly Beach, South Carolina, 5 September 1979.

Repairs began in December 1979. Most of the riprap was restacked and the concrete-block bulkhead was resurrected and backfilled. The Sandgrabbers and the concrete bulkhead were not repaired. As in the other monitoring areas, the devices in area 3 performed well under moderate wave conditions. The riprap and bulkheads protected the berm and landward structures from the surging waves and tides, while the Sandgrabbers slowly accreted sand. Figures 2-122 and 2-123 show the sand accumulation from September to December. The seaward Sandgrabber protected the other unit from initial wave contact, as evidenced by the number of broken blocks in the top row of each structure. The tandem positioning of the Sandgrabbers also hastened sand accumulation between them.

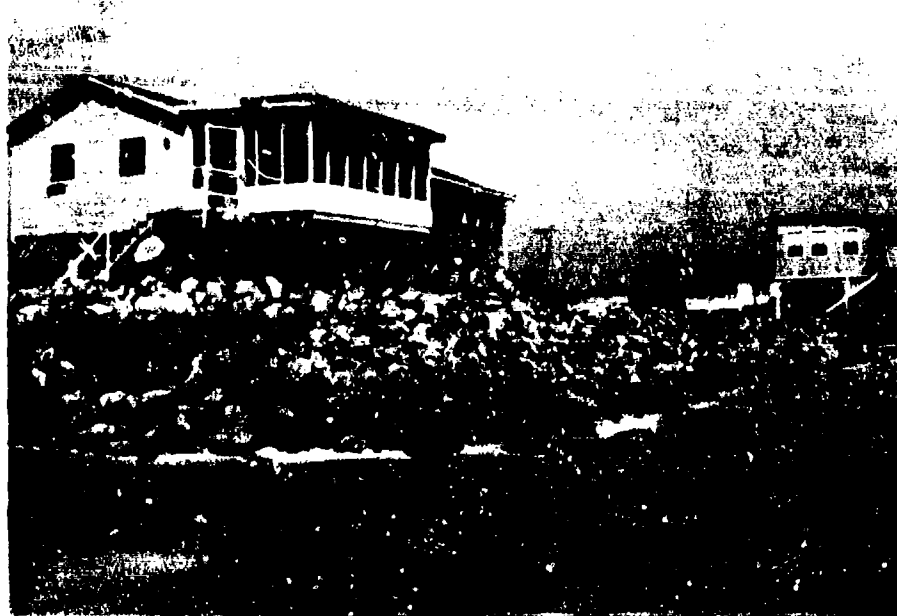
Figure 2-126. New riprap placed in front of building 1308 in device 10, Folly Beach, South Carolina, 5 March 1980.

Before the hurricane, some sand was accumulating behind the north end of the concrete bulkhead. Local erosion occurred where the revetments and bulkheads had failed (Figs. 2-124 and 2-125). In March 1980, new fill and riprap were placed where device 10 had been in front of building 1308 (Fig. 2-126). No additional changes were made as of May 1980. The two groins, devices 8 and 14, sustained little damage.

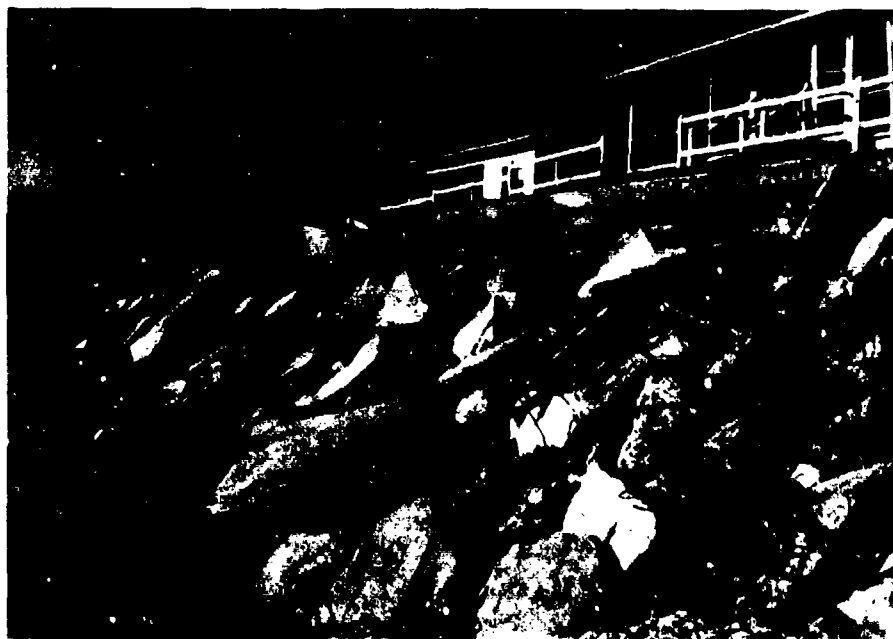
Figure 2-131. Broken concrete placed in front of device 15 bulkhead after storm, Folly Beach, South Carolina, 30 October 1979.

Special attention should be given to the modular concrete bulkhead. It protected the berm well during Hurricane David, failing in only one location. The entire length of the bulkhead should be fronted with toe stone (similar to that used in device 7), which would protect the structure from displacement due to toe scouring. The tandem arrangement of the Sandgrabber is unique. More monitoring is needed to determine whether the use of the sacrificial seaward Sandgrabber is cost-effective or whether some other alternative should be devised.

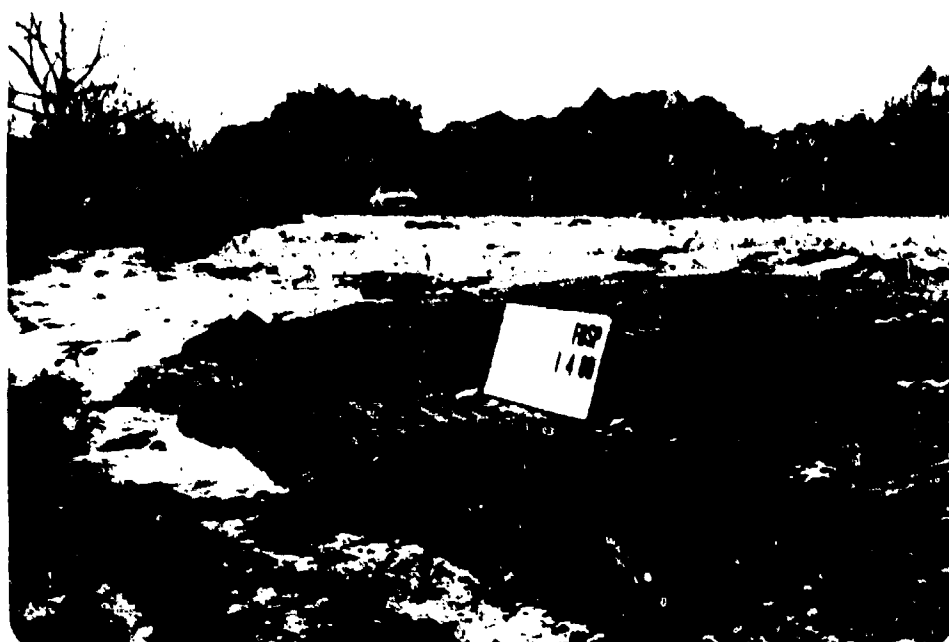
2 Performance. Some settlement occurred during the first inter of the monitoring period but no major changes in cross section were apparent. Soon after construction, the mat settled irregularly as shown in Figure 2-170. On 13 April 1980, a storm hit the area. The structure suffered no damage, although the lakeward edge of the mat was settling as a result of toe scour. The unprotected north end had subsided slightly before the storm, but the storm waves apparently did not aggravate this settlement (Fig. 2-171). The sand that had accumulated on the crown of the device was removed and washed over the access road by the storm. This structure was still intact by June 1980.

Figure 2-170. Photo shows a drop of approximately 10 inches (near sign) of the Erco-mat of device 1 and the protruding filter-cloth carrier strip used for placing the double mats, Fontainebleau State Park, Louisiana, 4 January 1980.

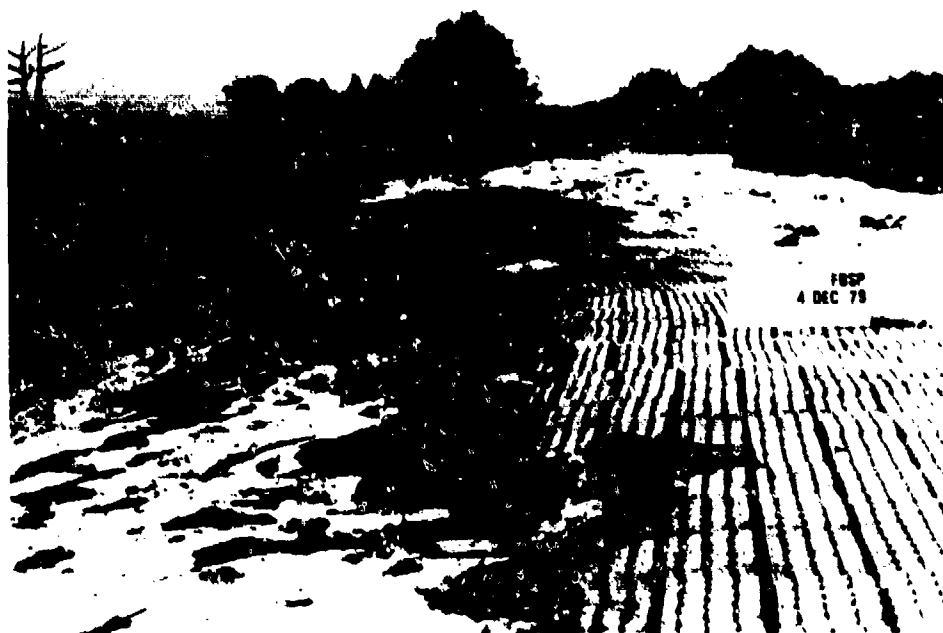
2 Performance. A month after construction, pieces of the carrier-strip filter cloth were protruding up between the mats (Fig. 2-174). The carrier strip is an integral part of the underside of each mat, and each mat has extra strips at each end for placing the mat. The revetment suffered no structural damage during the April 1980 storm, but the southern lakeward toe settled into the lake bottom. The objective of using filter panels and articulated mats is to allow the revetment to settle uniformly. Also, some of the construction blocks used to anchor the landward slope of the filter-cloth panel were exposed as a result of wave action washing the sand toward the marsh. As of June 1980, this structure had performed very well with no structural damage.

Figure 2-174. Photo shows the Jumbo-mat revetment, device 3, in the foreground. Note the filter-cloth carrier strip used for placing the mats, Fontainebleau State Park, Louisiana, 4 December 1979.

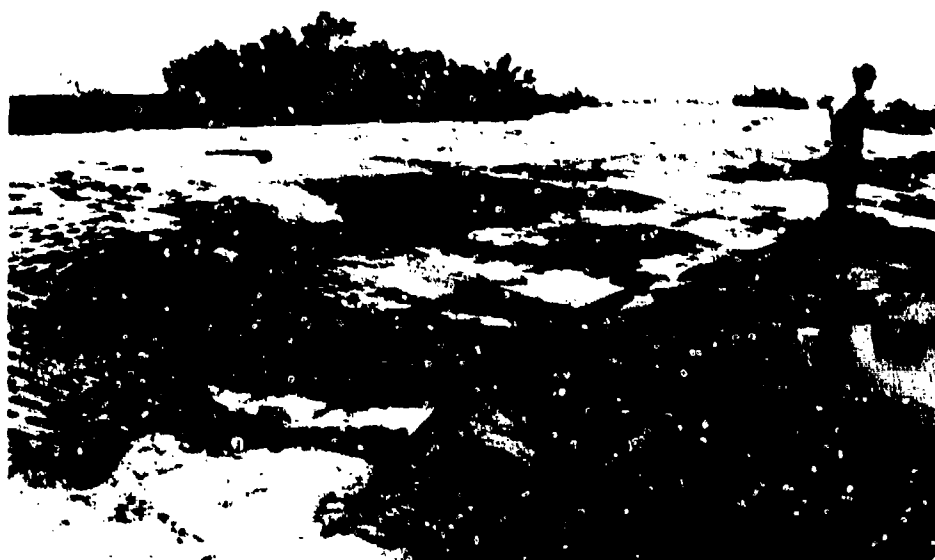
Figure 2-176. After the storm, blocks were displaced and the southern end of the filter cloth was exposed, Fontainebleau State Park, Louisiana, 9 May 1980.

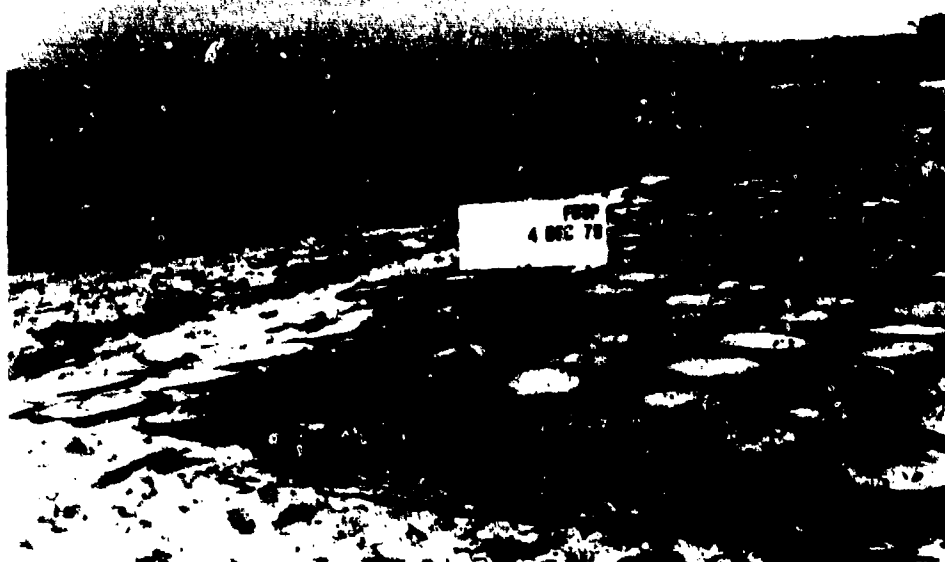
2 Performance. Two months after construction, the spaces between the bottom three rows of tires were filled with sand (Fig. 2-187). Vegetation sprouted in between the tires, but the survival rate was low. The Dutch toe settled as a result of toe scour and wave action. This is the purpose of the Dutch toe. After the storm of 13 April 1980, 50 percent of the tires were displaced by wave action (Fig. 2-188). As of June 1980, the structure was still intact, but a scarp had developed at the shoreline. At this point, the structure still protected the shore despite its damaged condition.

Figure 2-187. Sand had filled the voids between tires along the bottom three rows of device 9, Fontainebleau State Park, Louisiana, 4 December 1979.

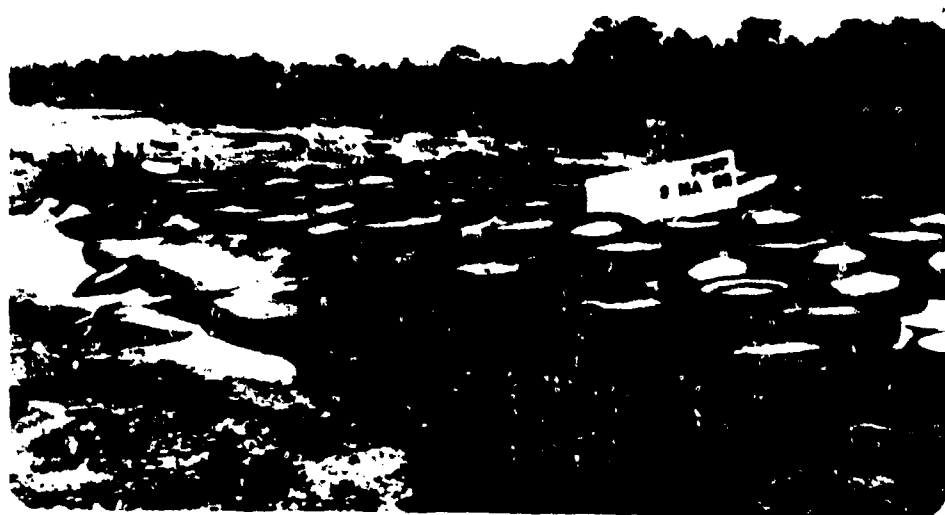
Figure 2-188. After the storm, the tires and Dutch toe were displaced, device 9, Fontainebleau State Park, Louisiana, 9 May 1980.

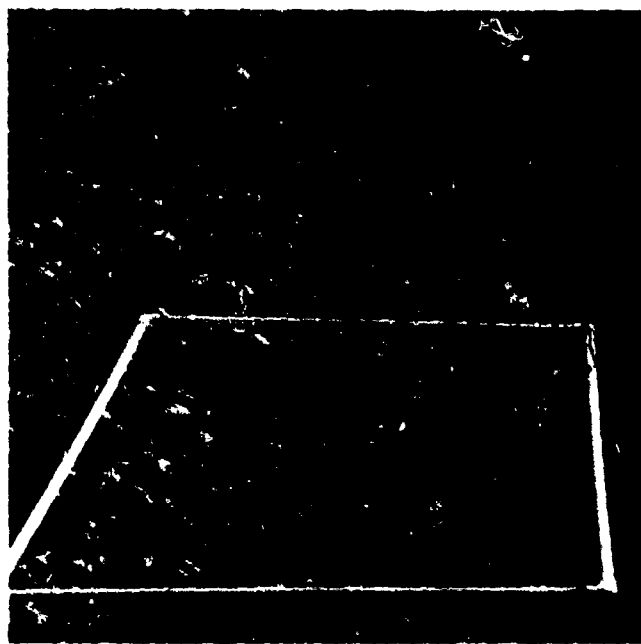
Figure 2-200. Stem counts in January 1980 reported seven stems per square meter of red mangrove and one stem per square meter of black mangrove, section Ew, Key West, Florida, 8 January 1980.

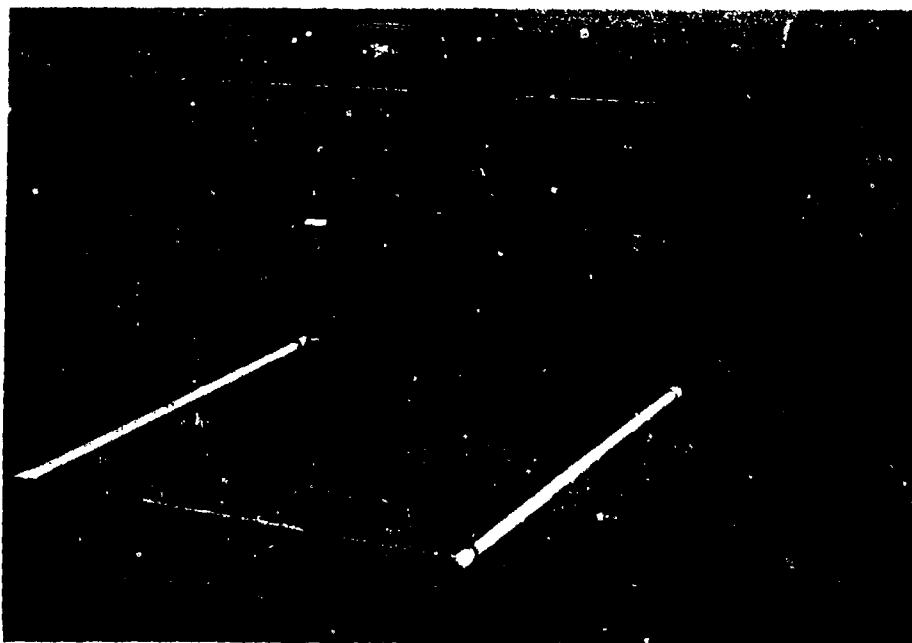
Figure 2-201. Stem counts in January 1980 reported two red mangrove stems per square meter in section E1eo, Key West, Florida, 8 January 1980.

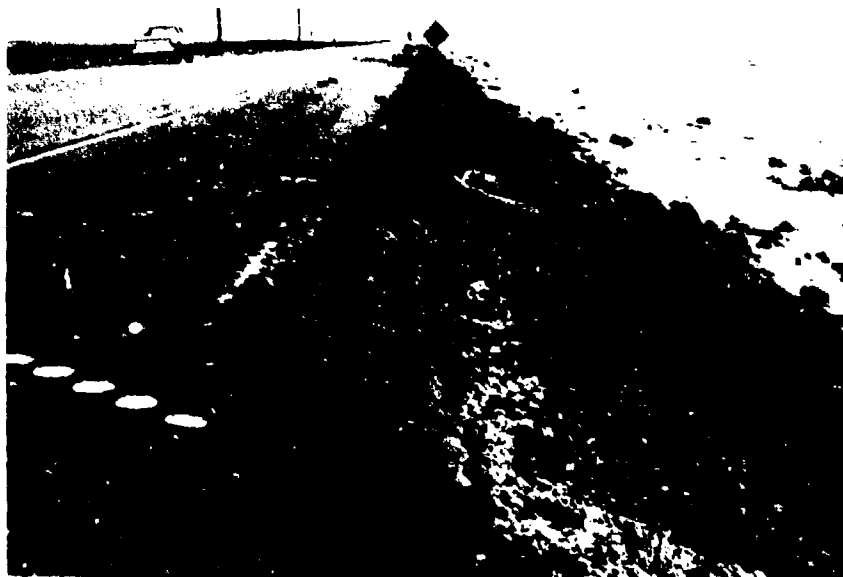
Damage to the revetment seemed to be initiated at the top where a construction joint connected the pervious concrete Gobi blocks to the impervious cement shoulder. Settlement of the shoulder trench due to inadequate compaction allowed the blocks to drop away from the soil-cement shoulder. Apparently, uplift pressures transmitted through the joint then lifted and destroyed large segments of the shoulder (Fig. 2-218). After the joint and shoulder had failed, loss of sand from underneath the revetment caused the remaining blocks to dislodge under the action of breaking waves and wave runup.

Figure 2-218. Shoulder destruction due to uplift pressures transmitted through joint, Holly Beach, Louisiana, 26 July 1979.

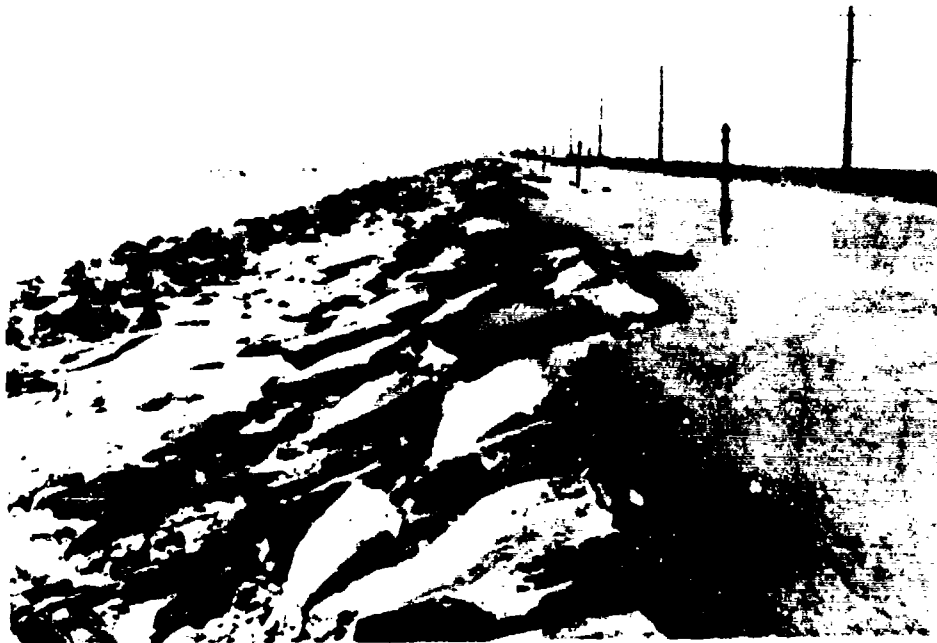
This project was not designed to withstand hurricane attack but rather to reduce maintenance required as a result of damage to the highway and shoulder by less severe storms. To this extent, the Gobi-mat revetment performed its intended function and protected State Highway 82. Had the revetment not been built, the sand chenier on which the road was built could have been severely eroded. Even during Tropical Storm Claudette, when several thousand square feet of shoulder was damaged or displaced, less than 1,000 square feet of roadway was damaged. As of April 1980, damage along parts of the revetment continued toward the traffic lanes and large sections of soil-cement have been displaced by wave action (Fig. 2-227).

Figure 2-227. During high tides, wave attack and runup undercut road shoulder due to displacement of filter cloth, Holly Beach, Louisiana, 16 April 1980.

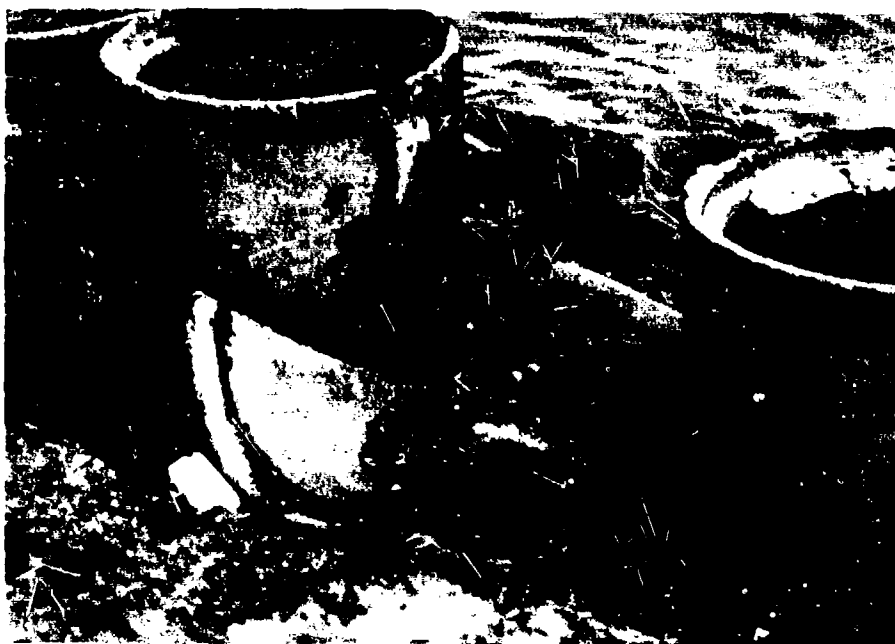
(3) Performance. During July 1979, storm waves caused some degradation of structural materials. The structure was overtopped and a 25-foot-long segment failed, destroying one pipe (Fig. 2-229). Several pipes underwent moderate displacement, and gaps between the pipes allowed some backfill erosion to occur (Fig. 2-230). For the next 4 months, minor deterioration of the structure continued along the segments breached during the storm.

Figure 2-229. Destroyed pipe along bulkhead, Beach City, Texas, 17 August 1979.

Reconditioning of the damaged section began in November 1979. By December 1979, the entire structure had been totally reconditioned, with spaces between all the pipes filled with concrete mortar, and earthfill placed in the pipes and behind the structure (Figs. 2-231 and 2-232).

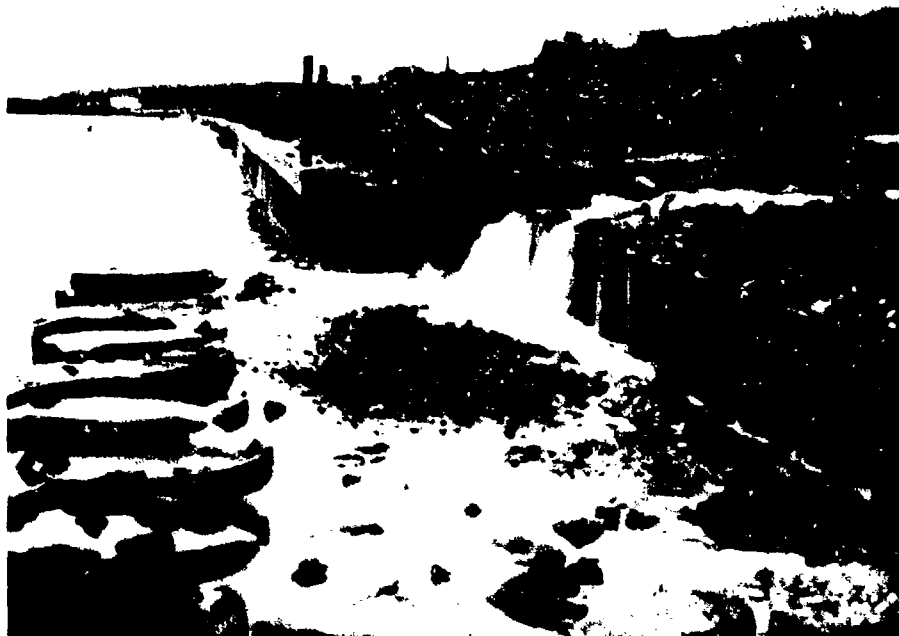
Figure 2-232. Backfill of structure; note seaward row of
pipes installed in an earlier project,
Beach City, Texas, 21 December 1979.

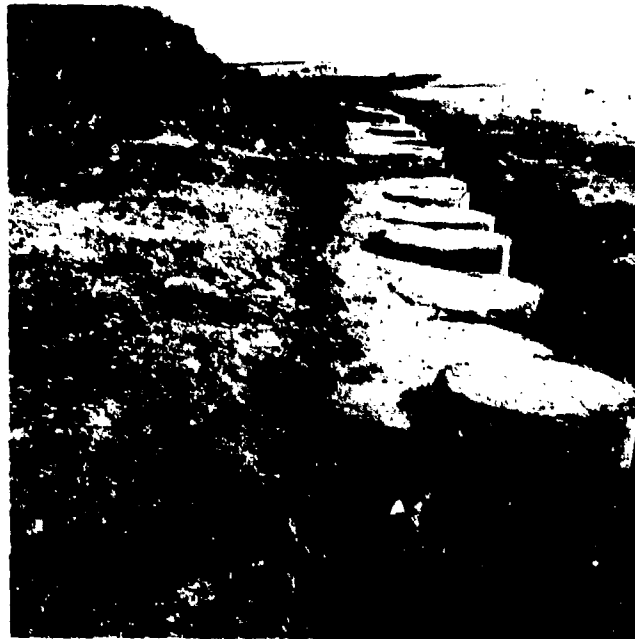
During the January 1980 site visit, a rain shower caused damages due to inadequate drainage (Figs. 2-233 and 2-234). In February 1980, capping of the structure with a 2- to 4-inch concrete cap, placed on top of and behind the pipe structure, was begun (Fig. 2-235). At this time, it was noted that a large hole had been washed out near a drainpipe at the southwest end of the shoreline (Figs. 2-236 and 2-237). In March 1980, the washed-

Figure 2-234. Drainage during rain showers, Beach City, Texas, 22 January 1980.

Although inadequate as originally installed, the structure after repairs and changes, prevented further shoreline erosion during the monitoring period. However, signs of incipient failure of the pipes (Figs. 2-234 and 2-240) indicated that the lifespan of the structure may not be as long as expected. A longer monitoring period is needed to adequately assess the performance of the structure.

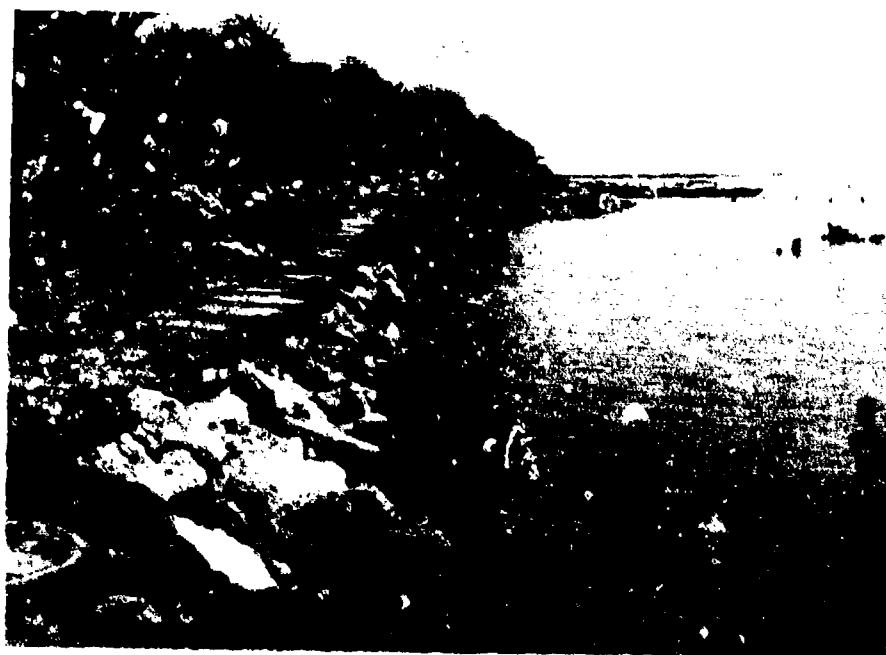
(4) Analysis. The structure as first installed was inadequate in preventing shoreline erosion because of (a) gaps between pipes which allowed backfill erosion, (b) inadequate toe protection which allowed toe scour, and (c) poor drainage which increased erosion. The use of granular backfill might have served to relieve hydrostatic pressure.

Figure 2-238. Toe scour, Beach City, Texas, 21 December 1979.

out hole was filled with concrete rubble. Also in March, concrete rubble was placed as toe protection in an effort to control toe scour occurring along some sections of the device (Figs. 2-238 and 2-239). In April 1980, additional broken concrete was placed at the toe of the structure for protection. As of May 1980 no additional structural damage had occurred.

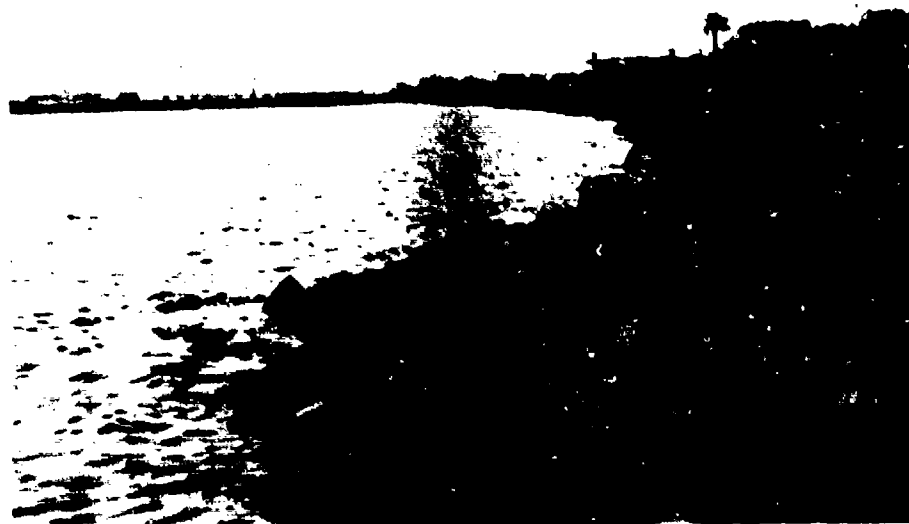
Figure 2-242. Typical segment of the riprap, Shoreacres, Texas, 19 July 1979.

1979; however, no noticeable changes were observed. The riprap has performed well functionally, preventing shoreline recession. In May 1980, the bank sloughed slightly in a few places, but caused no significant damage. Profiles of similar concrete rubble revetments are shown in Section III; the profiles through the revetment at Shoreacres are shown in Figure 3-43. Profiles show no erosion at the site.

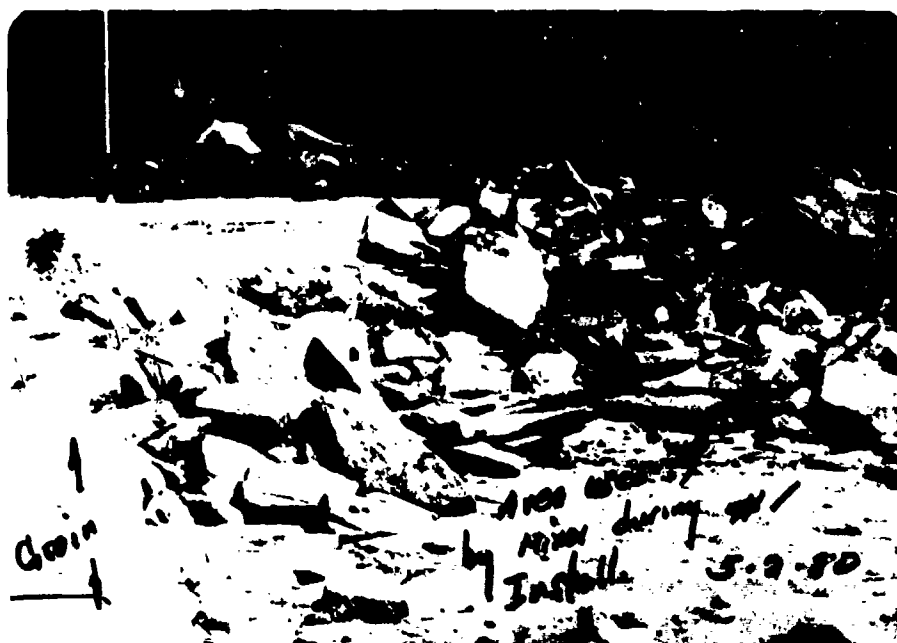
Figure 2-257. Erosion and emergency rubble on embankment, Alameda, California, 2 May 1980.

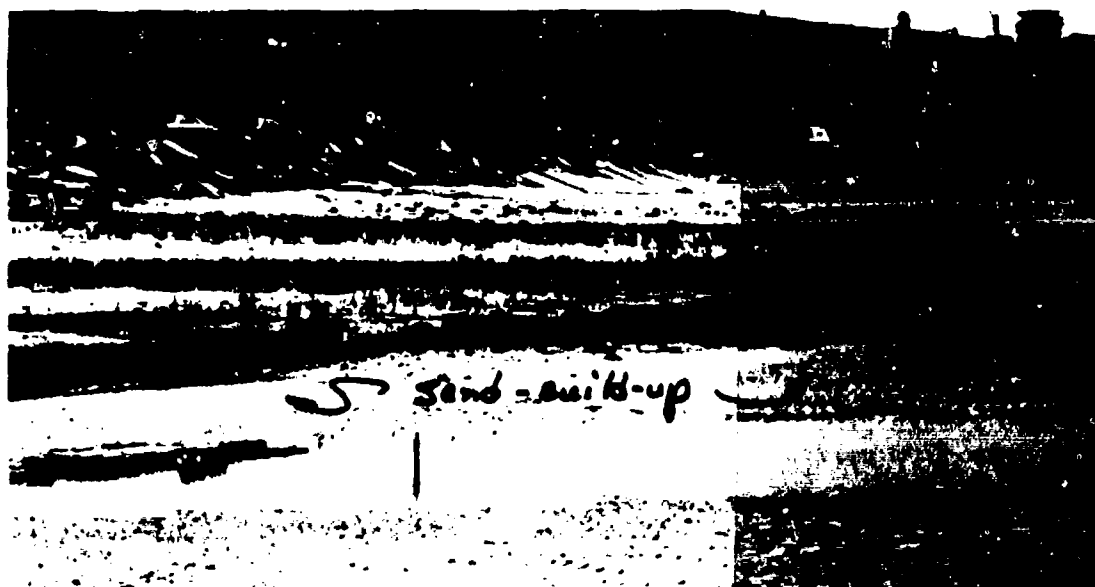
Despite the subsidence of parts of the breakwater, it continued to function as a low sill, retaining a fillet of sand cast over its crest by waves and protecting the device 3 vegetation plantings from wave damage. Sand accretion was most noticeable in the southwest corner adjacent to the groin. The nonuniform accretion of sand caused the formation of a small tidal pool in the planted area (Fig. 2-255). Considerable erosion occurred along the bank behind devices 2 and 3, attributed to the material being disturbed during construction. Emergency rubble was placed on the bank in November 1979 (Fig. 2-257). By May 1980, considerable shoaling (up to 1 foot or more) had occurred on the bayside of the breakwater (Fig. 2-258).

Figure 2-258. Accretion on bayside of device 2, Alameda, California, 2 May 1980.

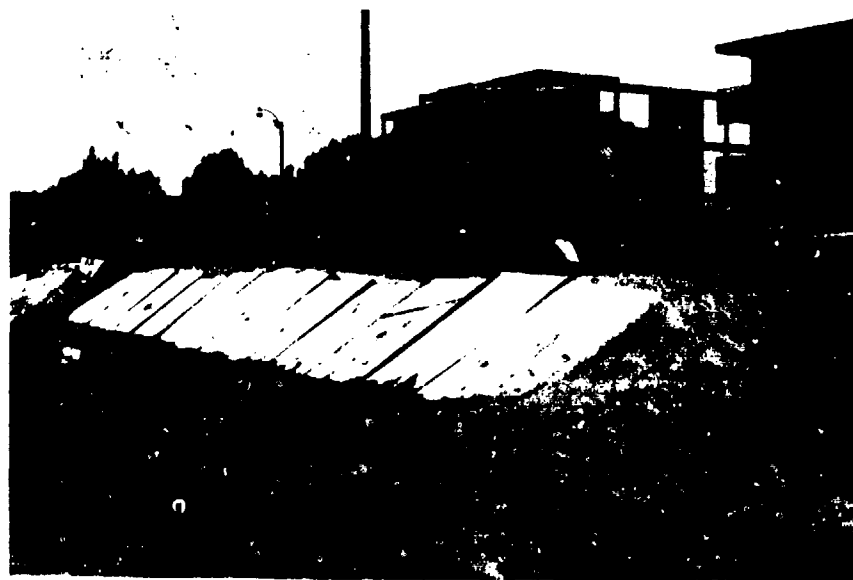
Figure 2-267. Concrete-slab revetment with filter cloth,
device 5, Alameda, California, 21 June 1979.

Figure 2-268. Concrete-slab revetment with filter cloth,
device 5, Alameda, California, 21 August
1979.

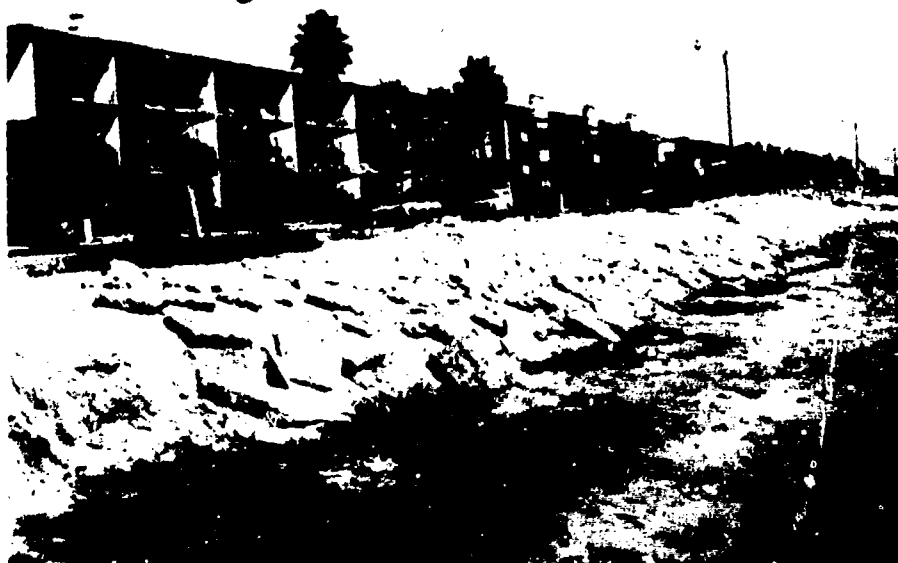
2 Performance. This 75-foot revetment, completed after the March 1979 storm, suffered only minor structural damage. Some of the sand placed over the filter cloth was washed away and some bank erosion occurred on the updrift side, but not enough to cause significant profile changes. Except for erosion of bluff material from behind the unprotected west end of the revetment, the structure adequately protected the bluff from wave erosion (Figs. 2-272 and 2-273) until February 1980 when the structure collapsed as a result of wave attack exposing the filter cloth and displacing most of the rubble (Fig. 2-274). As of May 1980 there was no severe erosion in the area.

Figure 2-272. Rubble revetment with filter cloth, device 6, Alameda, California, October 1979.
